Subject: Discoverer Enterprise

Reference: Acceptance of Well Control Equipment

WEST was requested by BP to go to the *Discoverer Enterprise* to perform an audit of the well control equipment in regards to its fit for purpose condition.

Section 3: WEST Recommendation Summaryy and Disposition Discoverer Enterprise, Job #3925; 27 Aprill to 16 May 2010 Prepared for BP

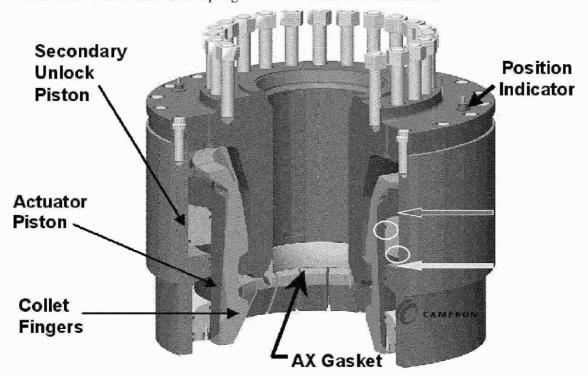
Figure 4.3: The yellow arrow shows the HC Collet Connector secondary unlatching cylinder, the two circles show the secondary piston seals, one of these two (or both) seals has failed causing operating fluid to migrate upward into the primary unlocking cylinder area, shown with the green arrow.

Prior to fitting the connector had operator pressure tests carried outto determine the integrity of the hydraulic circuits. The primary lock circuit and primary unlock circuit's were both successfully tested to 3,000 psi /10minutes. The secondary unlock circuit could not be tested and was found to be communicating with the primary unlock circuit, fluid was visible leaking back through the primary port at the connector head. The leak was witnessed by WEST and Transocean, pressure testing was suspended awaiting a response from the OEM and Transocean management.

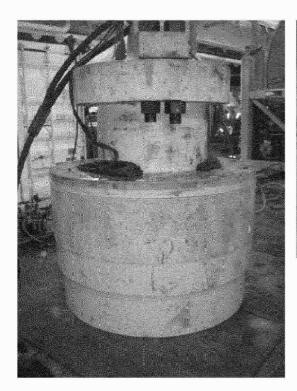
The Cameron HC Collet connector was removed from the set back area and prepared to be disassembled by the OEM, Cameron (See Figure 5.2). The body center section was removed from the body, while removing the center section, the collet cluster was fixed to the center section hub by way of cargo straps (See Figure 5.3). This will enable the connector to be rebuilt faster and with less manual handling of the collets while rebuilding. Further dismantling and inspection will be ongoing.

Figure 5.2: Shows the HC Connector prior to disassembly.

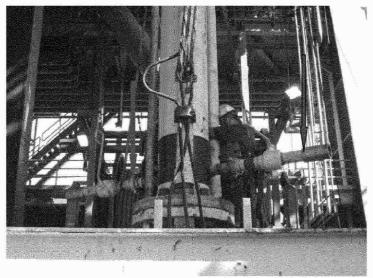
Figure 12.2: ROV operated ball valves (red arrows) installed and MUX cables installed on the riser joint.
